Manhole Inspection Summary

Manhole # S03YY1010MH

Insp Date: **9/21/06 3:01 PM**

Location Address: **3406 LUDGATE RD**

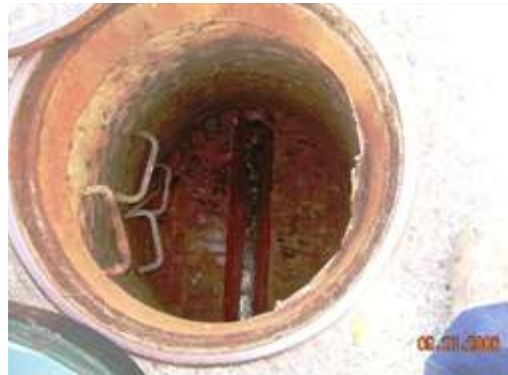
Top View

Condition: ☐ Sound ☐ Cracked ☐ Root Intrusion ☐ Loose Brick ☒ **Deteriorated**

Infiltration: ☐ None ☒ **Joint** ☐ Cracks ☒ **Mortar** ☐ Roots ☐ Wall

Infiltration: ☐ None ☐ Joint ☐ Cracks ☒ **Mortar** ☐ Roots ☒ **Wall**

Steps Count: **4** Missing: **0** ☒ **Corroded**

Adjustment deterioration and infiltration. Corbel and Barrel infiltration. Corroded steps. Bench and Channel debris.

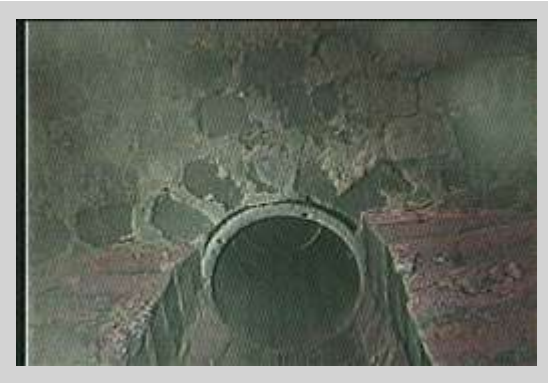
8 in. Circular Gravity Sewer Pipe Out @ 12 O'Clock

Barrel deterioration and infiltration.
